# Service Bulletin

## SAFETY RECALL

### 2001-2012 GL1800/A Secondary Master Cylinder Inspection/Replacement

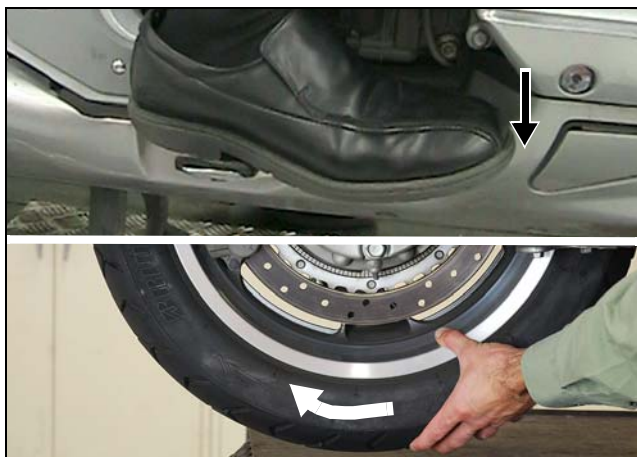
10. Firmly depress and slowly release the brake pedal five times, then release the brake pedal, wait five seconds, then try to rotate the rear wheel as shown.

- If the rear wheel rotates freely, the secondary master cylinder is OK. Proceed to Step 11.
- If the rear wheel is locked (does not rotate), the secondary master cylinder must be replaced. Proceed to the REPAIR PROCEDURE section of this bulletin.
- If the wheel is not locked, but feels like it has more drag than noted in Step 2, check the drag as shown with a spring scale (T/N: SAMIN12MRP). The rear wheel drag should be no more than:  
**50 N (5.1 kgf, 11.2 lbf)**

If the wheel drag is greater than specified, the secondary master cylinder must be replaced. Proceed to the REPAIR PROCEDURE section of this bulletin.

If the wheel drag is less than specified, the secondary master cylinder is OK; proceed to Step 11.
